FZK-263-1  
20 OCTOBER 1965

**NERVA MATERIALS  
IRRADIATION PROGRAM**  
Volume 1  
**GTR Test 16 — AGC Materials Test**

Prepared for  
Space Nuclear Propulsion Office  
of the  
National Aeronautics and Space Administration  
Cleveland, Ohio

**NUCLEAR AEROSPACE RESEARCH FACILITY**

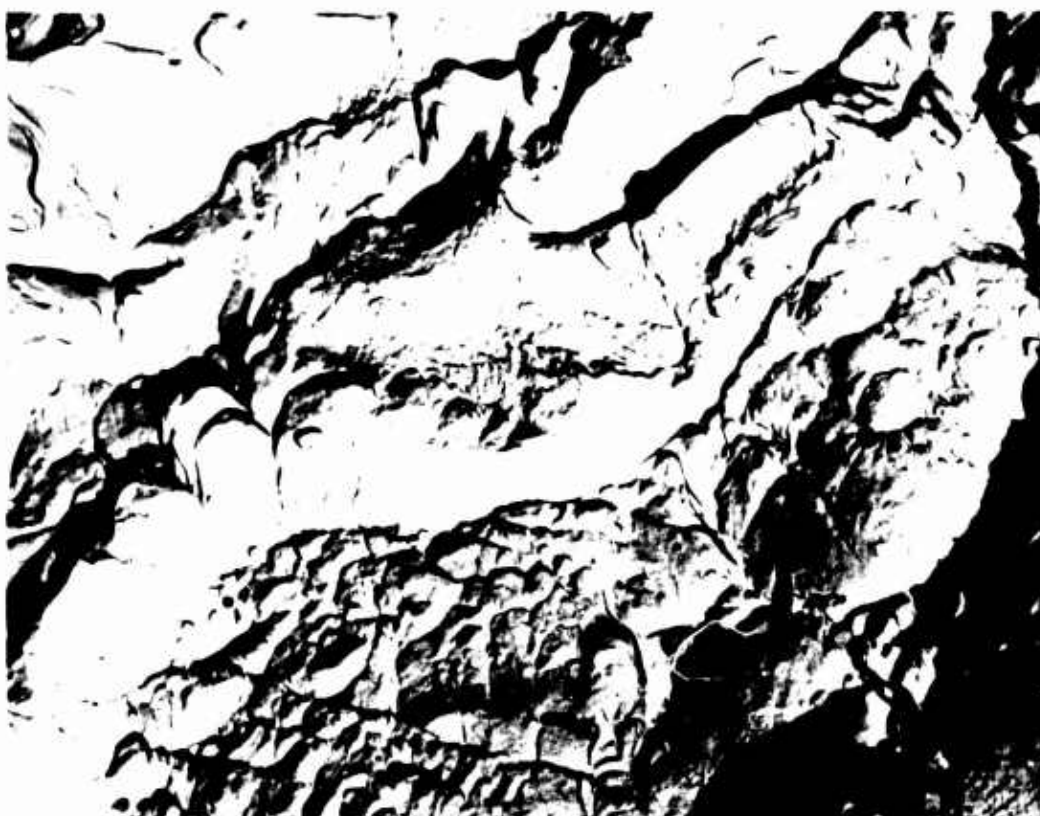
Material Titanium A-110-AT Neg.No. 99-4  
Specimen TWN 342 Neg.Mag. 2,100X  
Etchant None Photo Enlargement 2X

The fracture of this notched specimen was through the weld zone and the acicular microstructure is reflected in the fracture topography. What is probably a grain boundary begins in the lower left-hand corner and passes through the center of the photograph. The flat facet in the center of the photograph above the grain boundary has a cleavage-type pattern indicating the effect of orientation on the fracture, which is primarily microvoid.
